APPENDIX K

WATER TEST

PREPARED BY FLAIR FOUNTAINS

2016

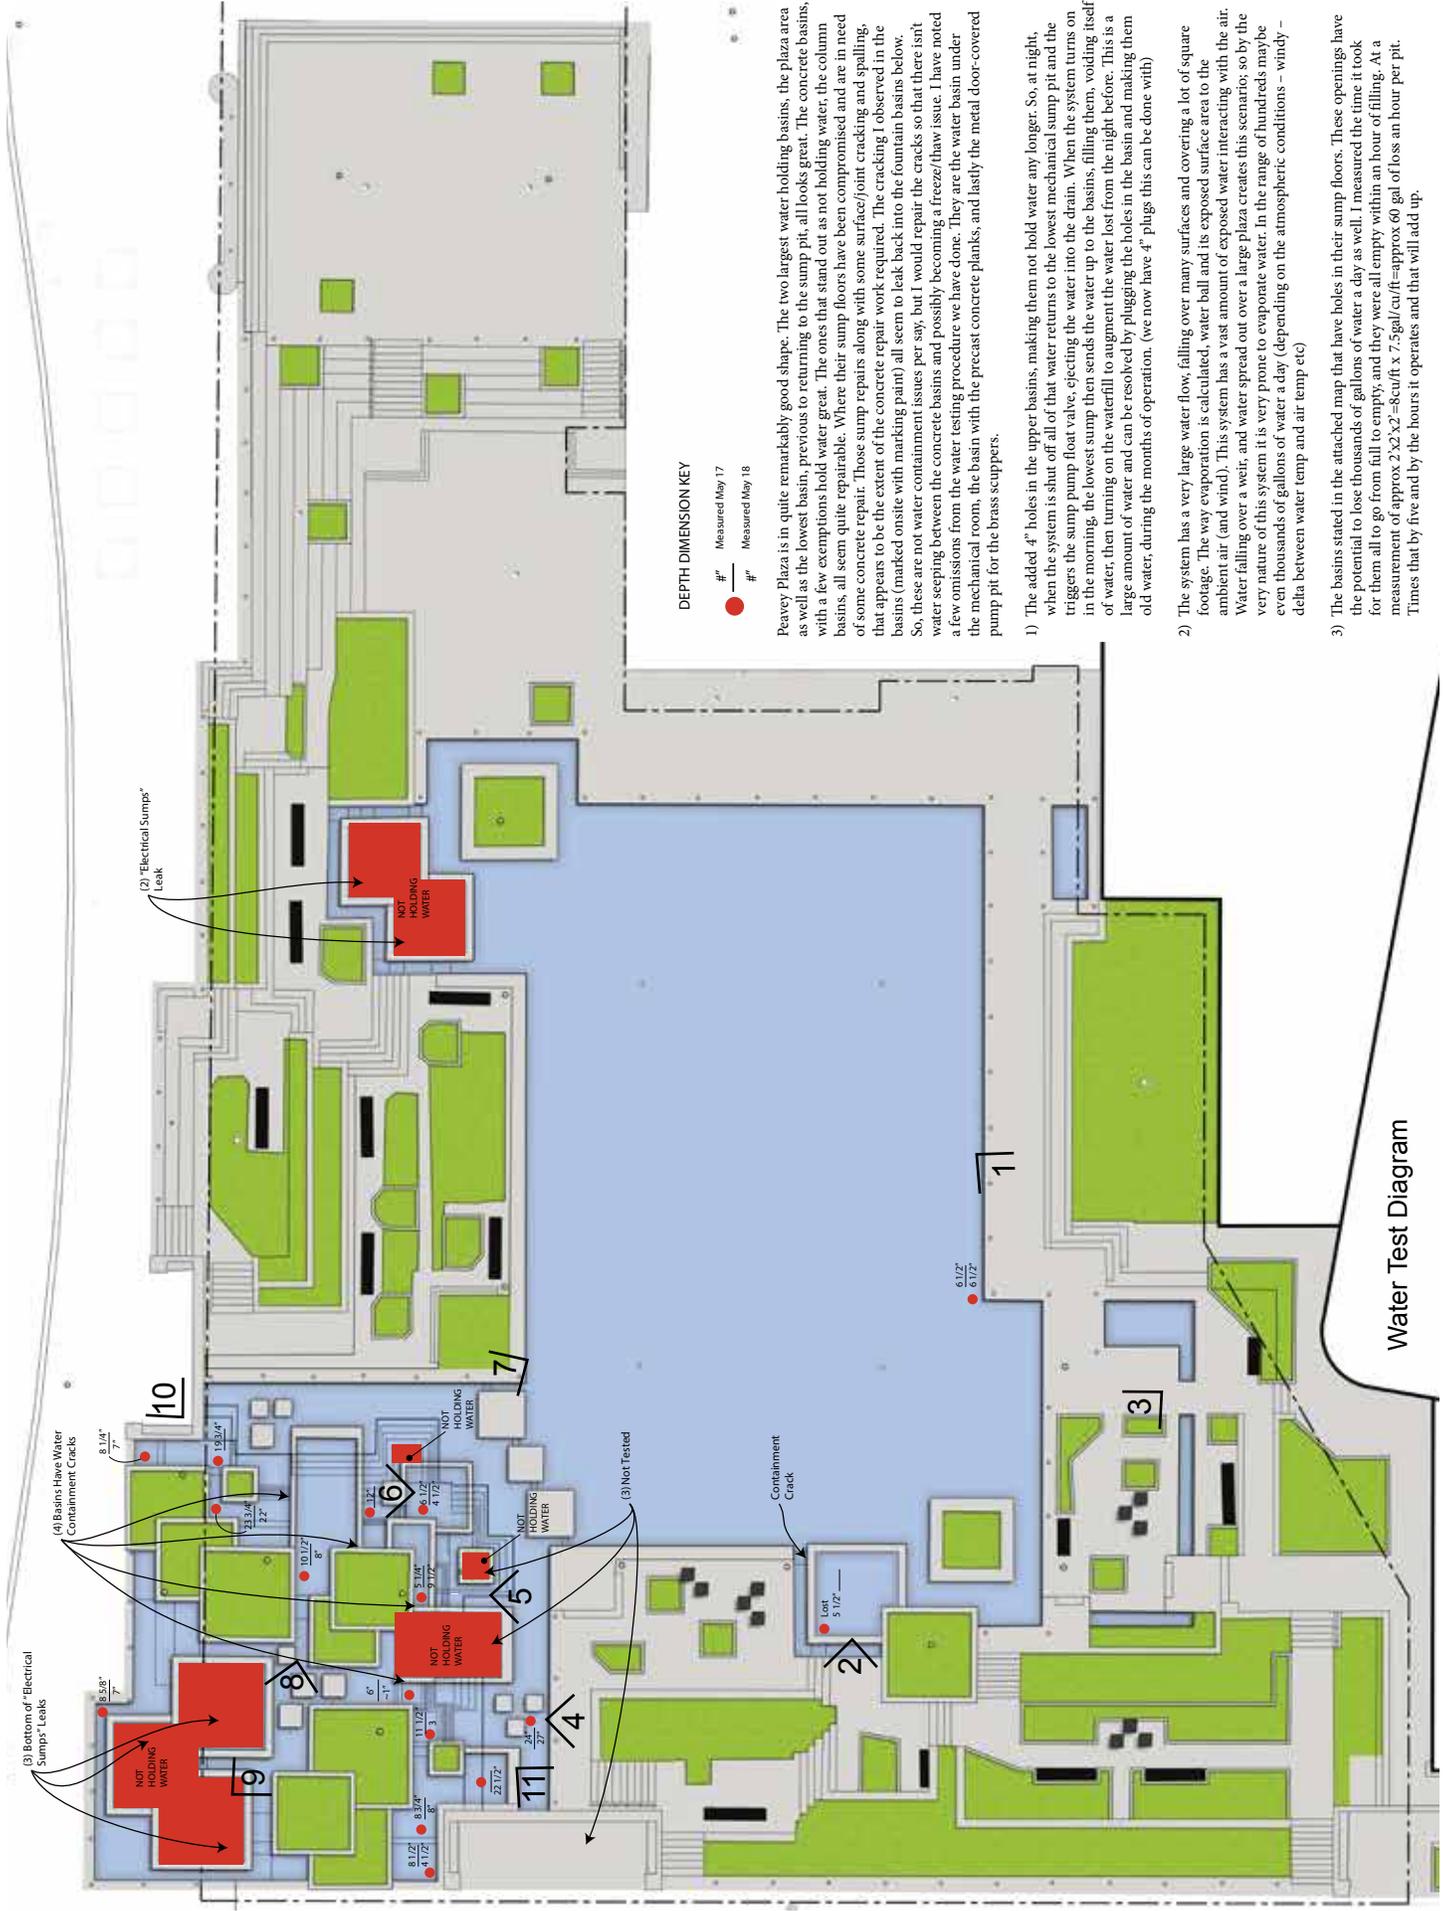
Water Test Diagram

DEPTH DIMENSION KEY

Peavey Plaza is in quite remarkably good shape. The two largest water holding basins, the plaza area as well as the lowest basin, previous to returning to the sump pit, all looks great. The concrete basins, with a few exemptions hold water great. The ones that stand out as not holding water, the column basins, all seem quite repairable. Where their sump floors have been compromised and are in need of some concrete repair. Those sump repairs along with some surface/joint cracking and spalling, that appears to be the extent of the concrete repair work required. The cracking I observed in the basins (marked onsite with marking paint) all seem to leak back into the fountain basins below. So, these are not water containment issues per say, but I would repair the cracks so that there isn't water seeping between the concrete basins and possibly becoming a freeze/thaw issue. I have noted a few omissions from the water testing procedure we have done. They are the water basin under the mechanical room, the basin with the precast concrete planks, and lastly the metal door-covered pump pit for the brass scuppers.

- 3) The basins stated in the attached map that have holes in their sump floors. These openings have the potential to lose thousands of gallons of water a day as well. I measured the time it took for them all to go from full to empty, and they were all empty within an hour of filling. At a measurement of approx 2.82 = 8cu/ft x 7.5gal/cu/ft=approx 60 gal of loss an hour per pit. Times that by five and by the hours it operates and that will add up.

- 1) The added 4" holes in the upper basins, making them not hold water any longer. So, at night, when the system is shut off all of that water returns to the lowest mechanical sump pit and the triggers the sump pump float valve, ejecting the water into the drain. When the system turns on in the morning, the lowest sump then sends the water up to the basins, filling them, voiding itself of water, then turning on the waterfall to augment the water lost from the night before. This is a large amount of water and can be resolved by plugging the holes in the basin and making them old water, during the months of operation. (we now have 4" plugs this can be done with)
