Washburn-Fair Oaks Historic District Design Guidelines

Prepared for the Minneapolis Heritage Preservation Commission
City of Minneapolis
Department of Community Planning and Economic Development (CPED)

Prepared by
Pigeon Consulting, CPED, and Ten x Ten

Adopted June 18, 2024

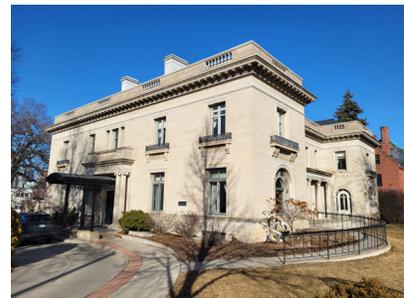
The Gale Mansion at 2115 Stevens Ave is a good example of Italian Renaissance Revival architecture. The stone columns, arched windows, and decorative cornice are part of its historic character.

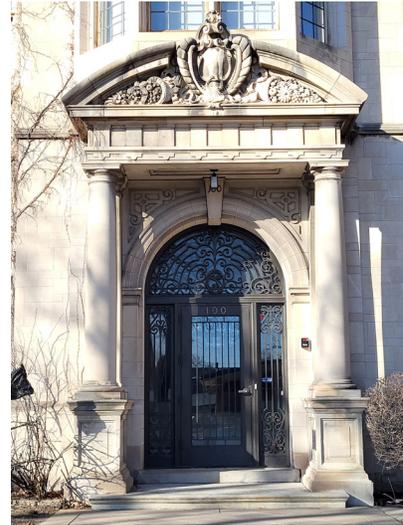
This stone entry at 100 22nd St E is a distinctive historic feature. The pediment above the door has carvings of fruits and flowers.

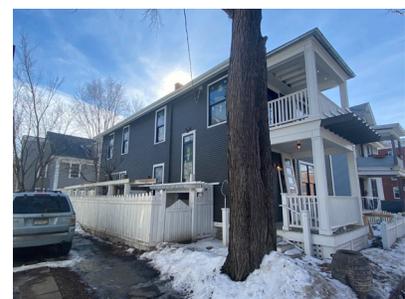
105 25th St E in 2022. This house was built in 1908 and is a contributing resource. Note how the front porch has changed since the 1980s. The porch is one of its non-historic features.

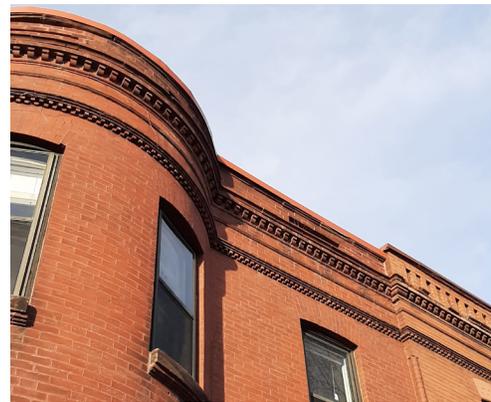
Note the historic brickwork at 100 25th St E. These rowhouses have brick dentils and brackets along the cornice line.

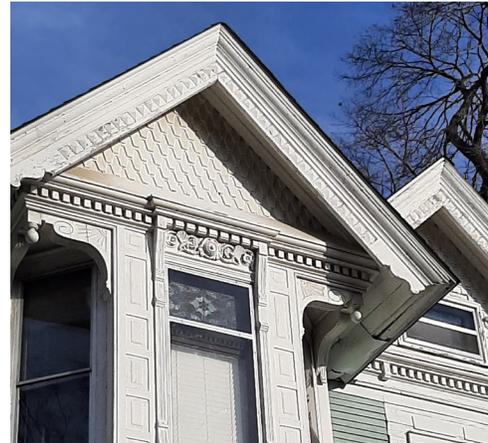
The house at 2429 1st Ave S has many historic wood features. The green lap siding, paneled trim around the windows, and shaped shingles in the gable ends are all original. The gables also have a row of dentils, bargeboards along the eaves, and scroll brackets in the overhang.

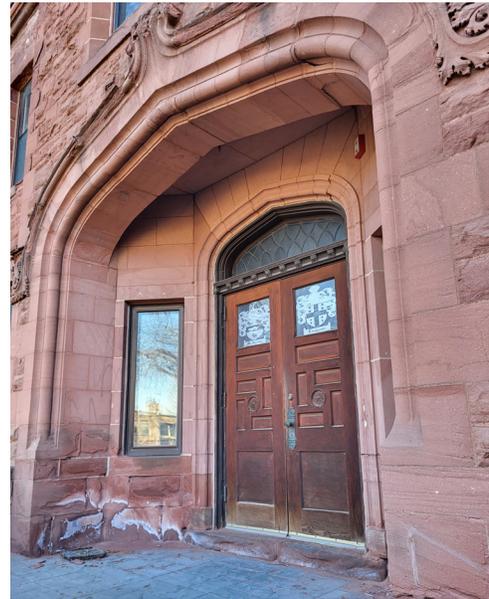
The historic wood door is present at 2116 2nd Ave S. It has a decorative frame and a leaded transom window above. It is important to preserve these features.

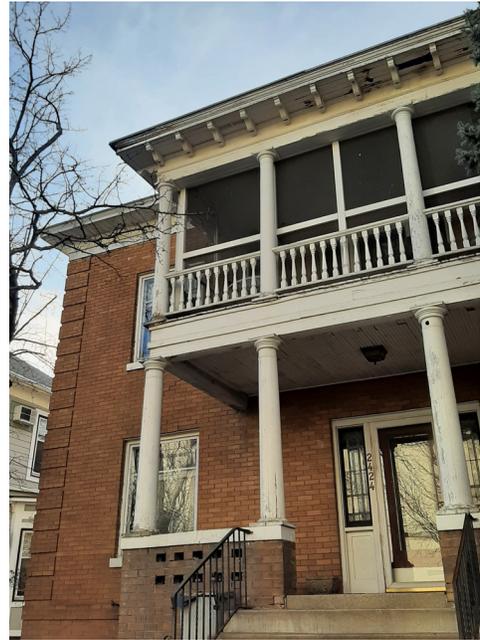
This two-story porch at 2424 Stevens Ave has historic architectural details that should be retained. Wood Tuscan columns support the structure. Turned wood railings line the second story.

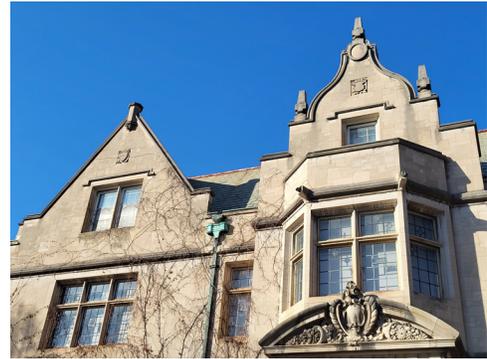
The house at 100 22nd St E has several historic roof features. The roof is covered with slate. The gutters are built into the roof. Stone parapets extend up from the roof. The one on the left is pointed. The one on the right is stepped and scalloped with carved finials.

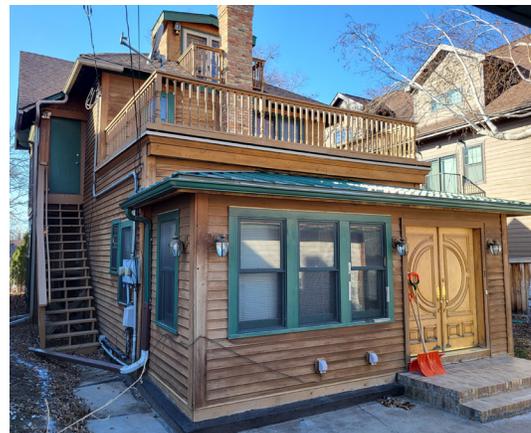
At 2417 1st Ave S, there is a one-story rear addition, built in 2003. It is smaller than the original building. The roof shape and material differ from the original building. The window pattern is contemporary and still compatible.

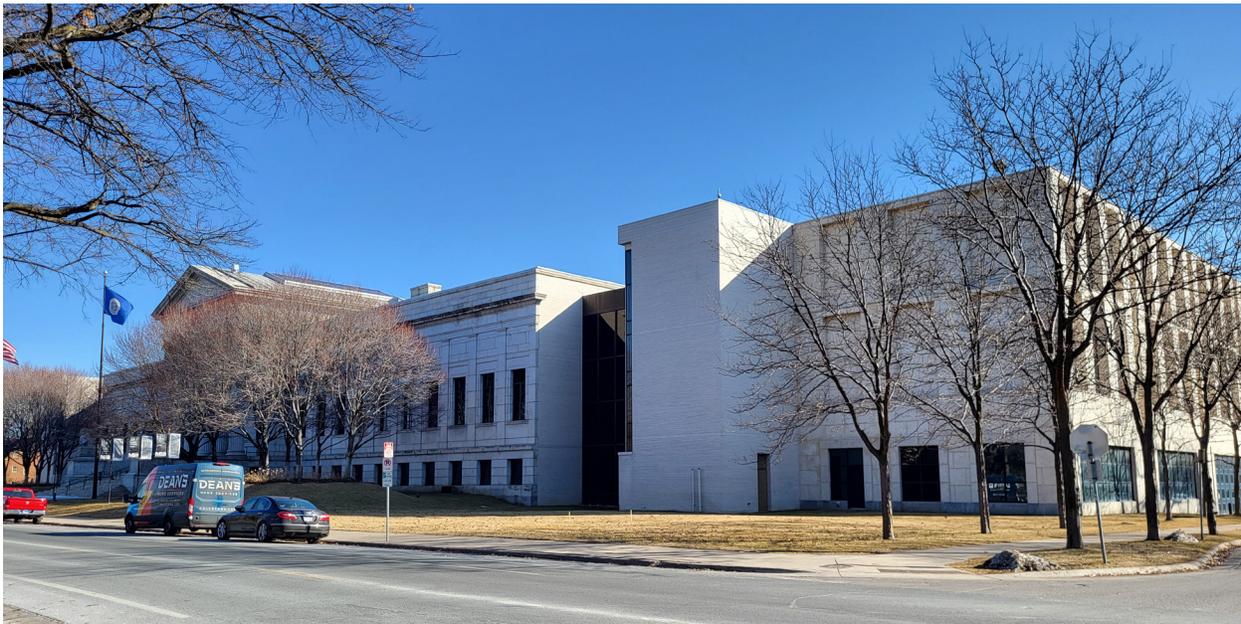
The original building for the Minneapolis Institute of Art (MIA) is shown at left. It was designed by the prominent architectural firm McKim, Mead, & White. Michael Graves designed a contemporary addition at right. The original building was finished in 1915 and the addition opened in 2006. The addition does not copy the design of the historic building.

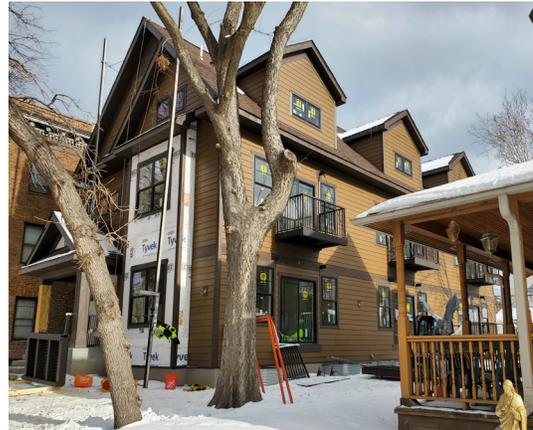
The house at 2413 1st Ave S was built in 2022 and is compatible with the historic district. Its main entrance faces the street. It is 2.5 stories tall and aligns with the neighboring buildings.

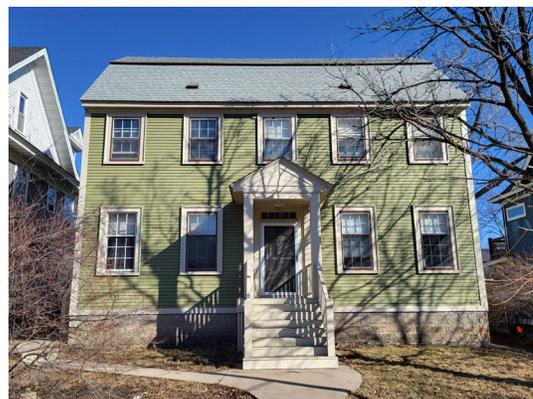
Built in 1998, the house at 2515 1st Ave S has a masonry foundation and one cladding material. The windows have divided lights.

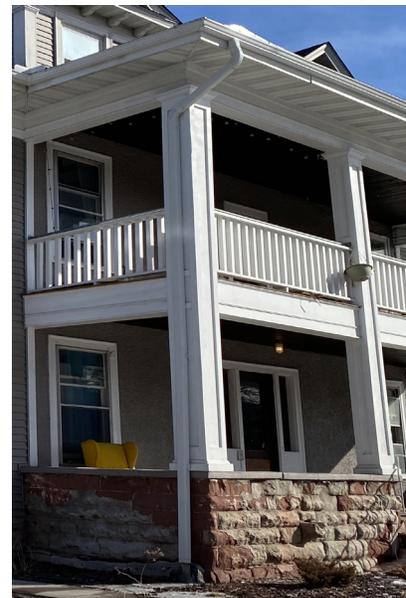
The square railing posts at 2511 1st Ave S are simple and do not mimic historic designs.

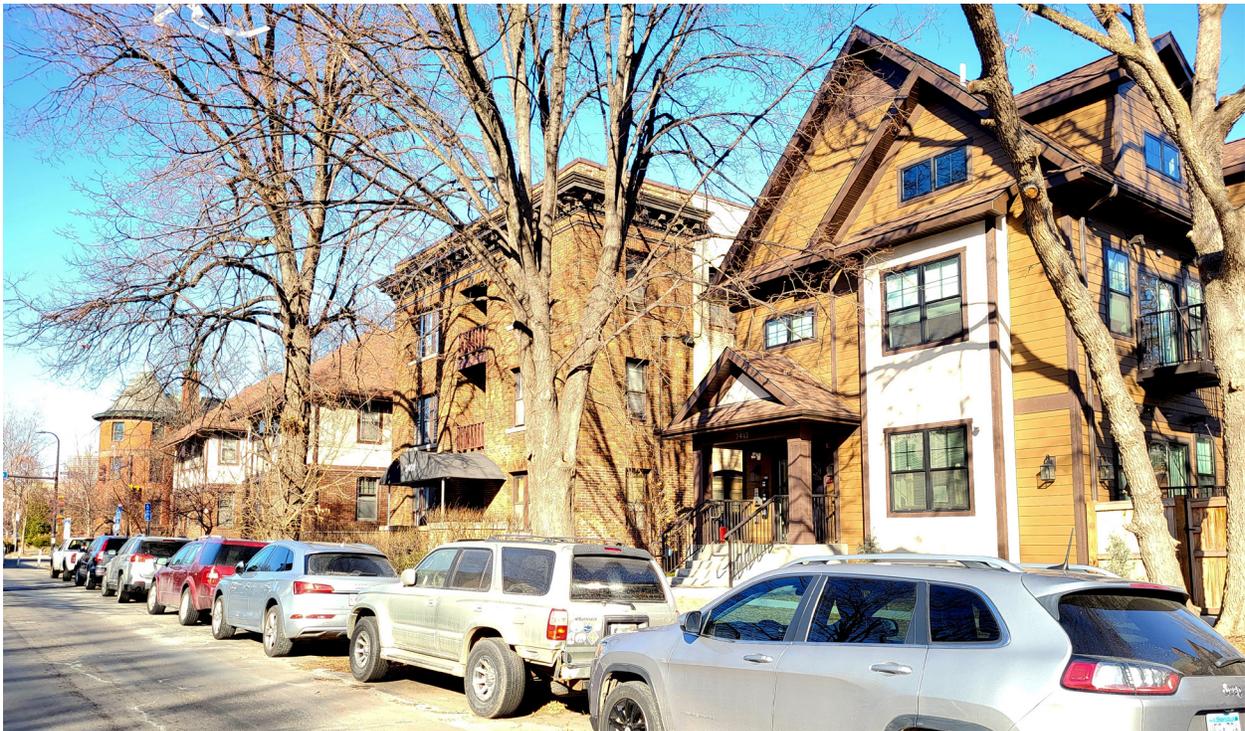
View of 1st Ave S between 24th St E and 25th St E. The building at 2413 1st Ave S (at right) is an example of compatible new construction. It fits with the character of the historic buildings to the left.

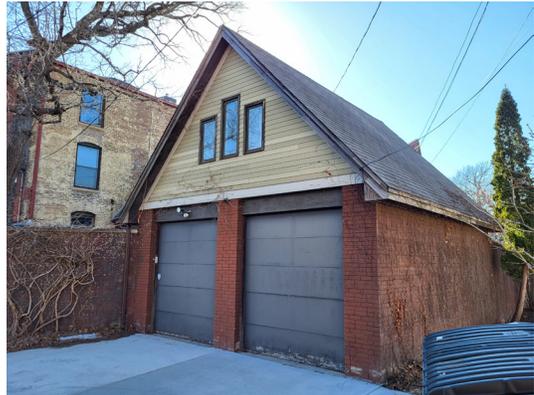
This garage at 108 24th St E uses materials that are appropriate in this district. The walls are clad in brick and lapped siding. The windows are wood and the roof has asphalt shingles.

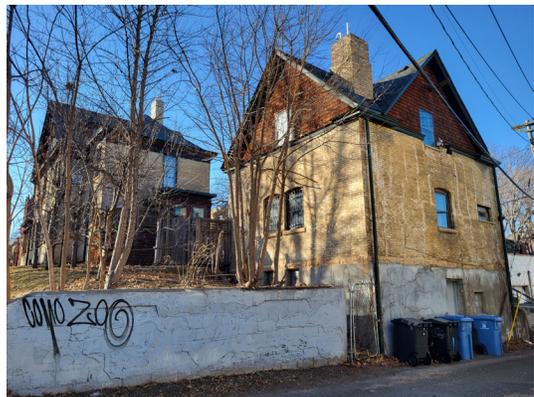
This accessory building (right) was constructed in 1899 as a barn for the main house (left) at 2117 2nd Ave S. It retains its historic wall cladding, which matches the main house.

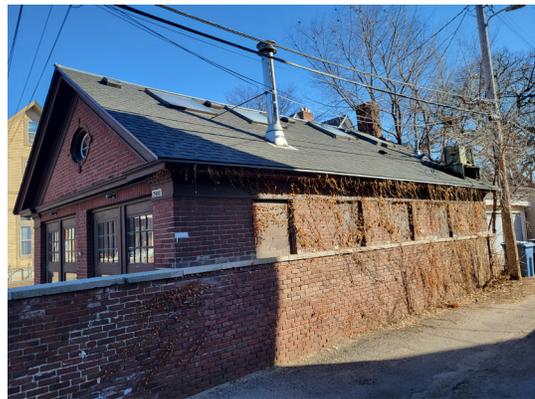
This carriage house at 2404 Stevens Ave has modern skylights and HVAC equipment on its rear roof slope. This location is not visible from the street.

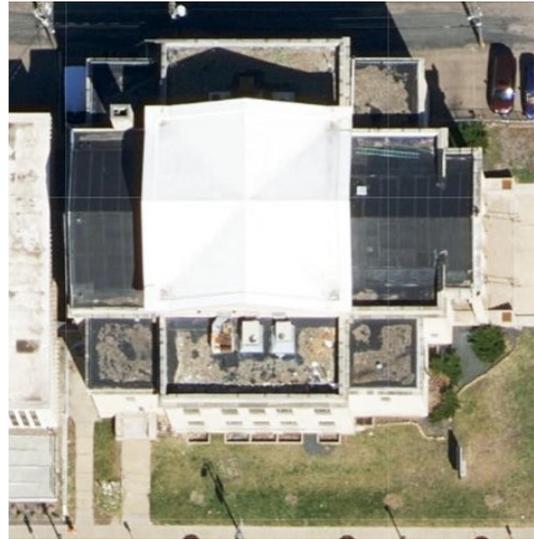
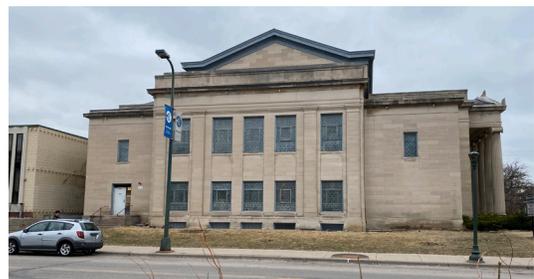
This is the Minneapolis First Seventh-day Adventist Church at 4 24th St E. On the bottom is a view of the west elevation. On the top is an aerial view (Courtesy of MinneAtlas).

The rooftop mechanical equipment is set back significantly. The rooftop units are not visible from the street.

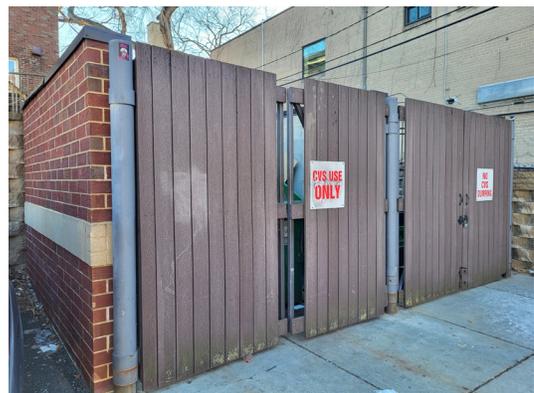
The trash enclosure at 15 Franklin Ave E is simple. It uses brick and wood pickets.
